UNDERWATER FACILITIES
INSPECTION AND ASSESSMENT
AT

NAVAL SUPPLY CENTER
SAN DIEGO,
CALIFORNIA

F P O - I - 83- (43)

Sept., 1983

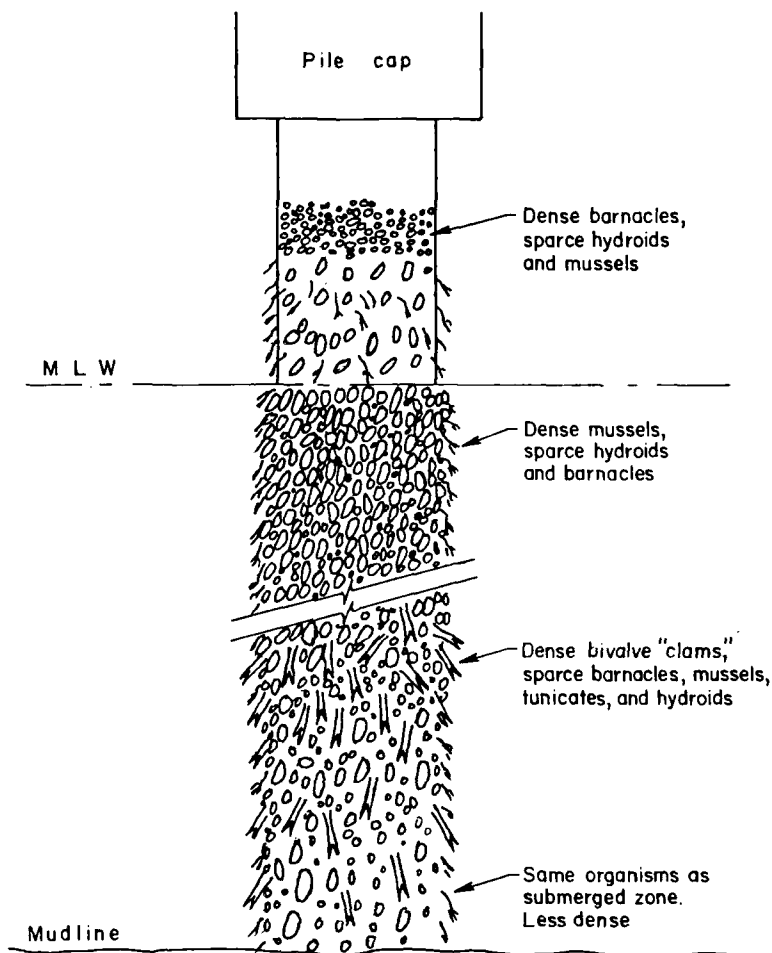
Marine growth or fouling profiles were found to be similar throughout the structure. Organisms found on or near the structure include barnacles, mussels, bivalve clams, hydroids and tunicates. In addition, several species of fish, crabs and lobsters were observed. The fouling organisms attached to the piles or concrete bulkhead were found to range from the upper intertidal zone to the mudline. Specifically they were found to range as follows:

Upper Intertidal Zone:	Dense barnacles, sparse hydroids and mussels
Mid - Lower Intertidal Zone:	Dense mussels, sparse hydroids and barnacles
Submerged Zone to Mudline:	Dense bivalve "clams", sparse barnacles, mussels, tunicates and hydroids

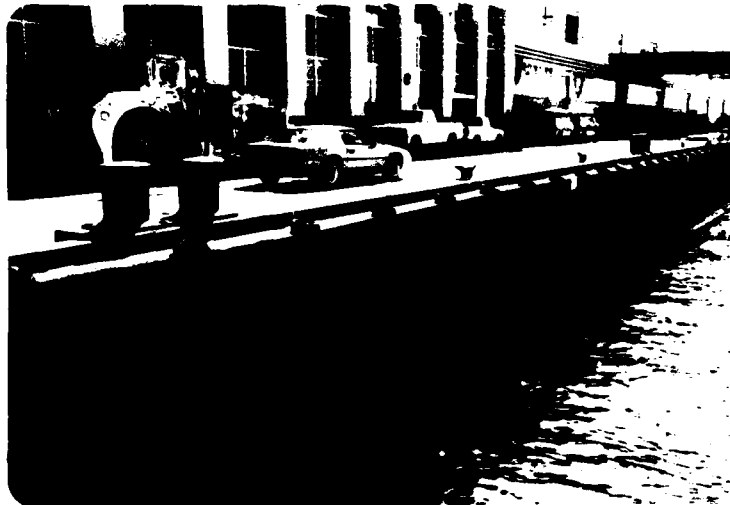
PHOTOGRAPH NO. 9

North Apron of Pier 11A. Note two story warehouse and timber fender system around perimeter of structure.
